## CASE STUDY

### Double Benching Operator Technique Issues

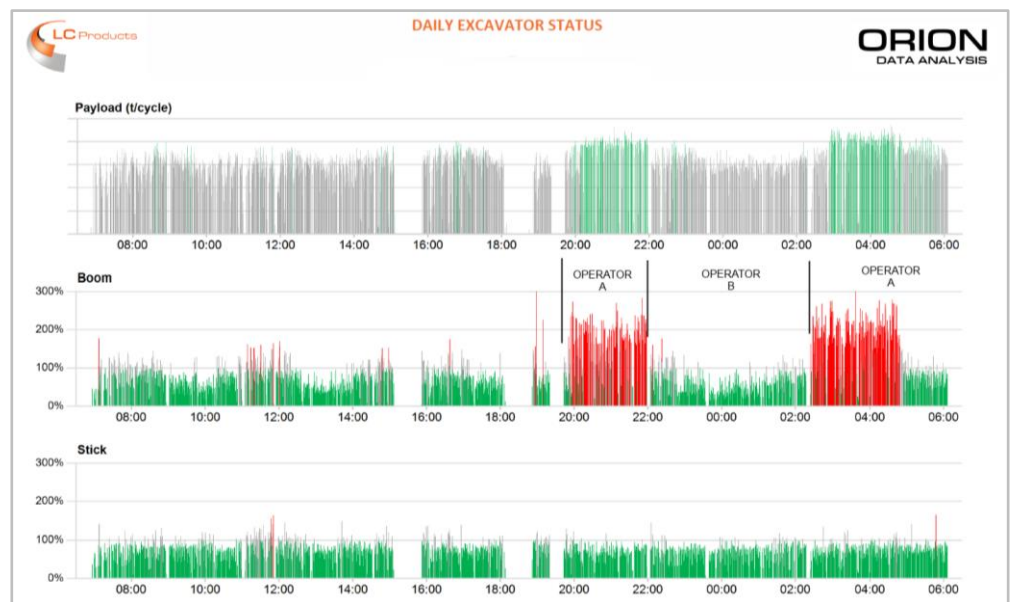
It was identified in a shift that there were extended periods of high boom fatigue duty rate which started and stopped very rapidly. These periods were found to coincide with the change in operator during the shift and that it was specific to one operator.

Figure 1 - Daily status report showing sudden and considerable changes in fatigue duty rate

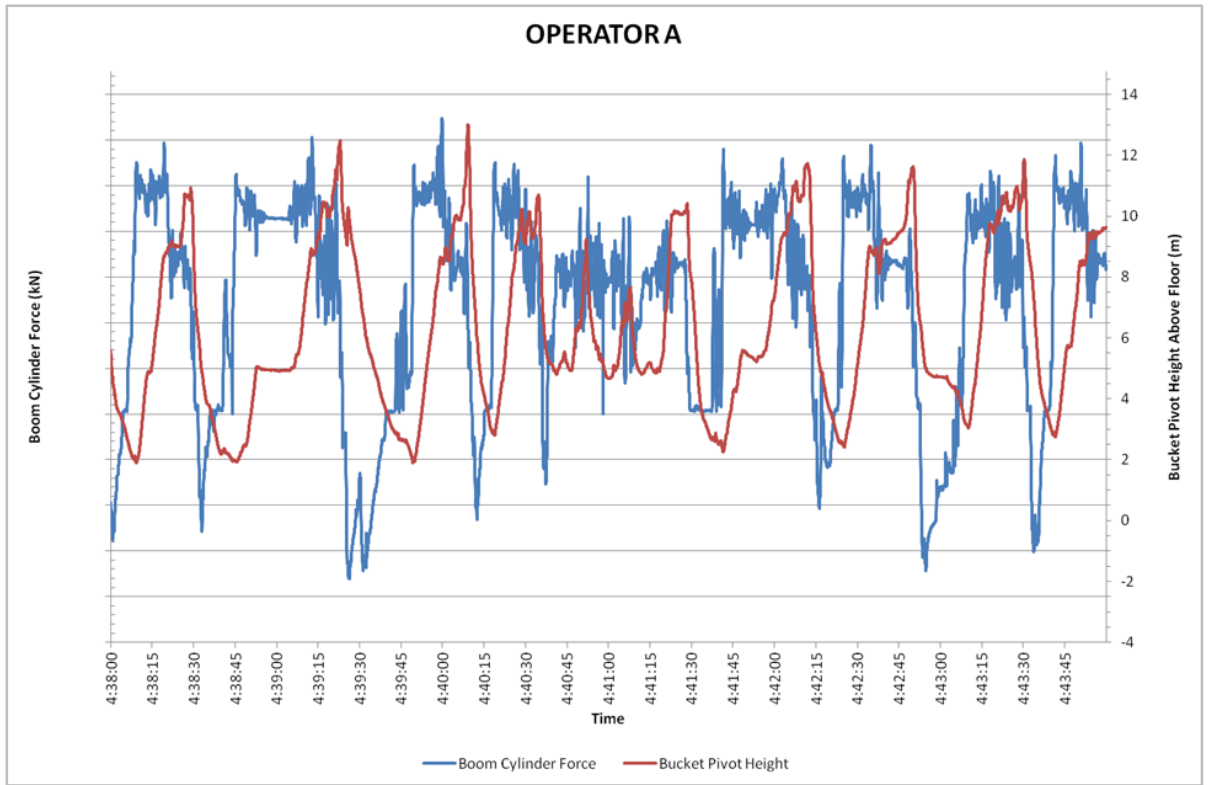
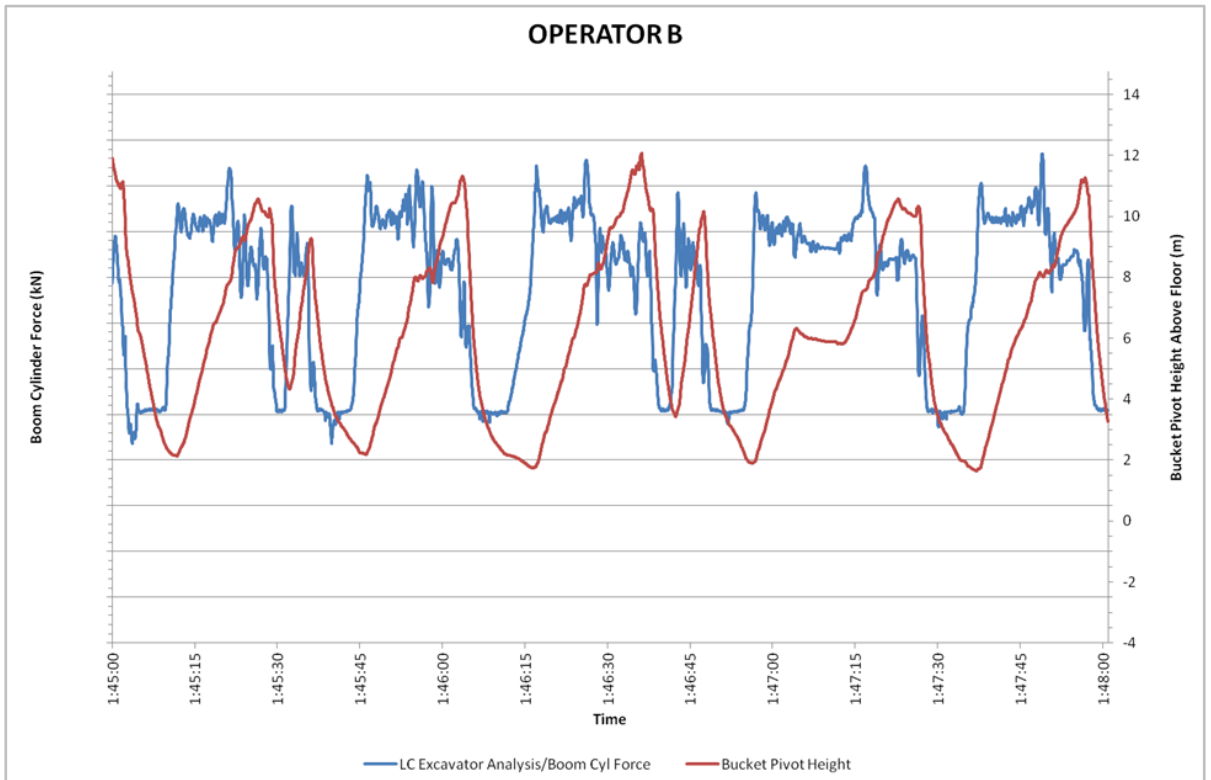
LC gained access to the data that the Titan system records at 20Hz to determine what the machine was doing at the time. It was found that throughout the shift the machine was double benching and that the way Operator A was performing this was causing their fatigue rate to double.

The following charts show brief periods of the measured boom cylinder force plotted against the height of the bucket pin above the floor for both operators A and B. Comparing the two it is easy to see that Operator A does something to make the boom cylinder force to go substantially negative (-600kN) indicating a high retraction force. It is this increase in boom cylinder force range that results in a doubling of fatigue duty rate. It was identified in a shift that there were extended periods of high boom fatigue duty rate which started and stopped very rapidly. These periods were found to coincide with the change in operator during the shift and that it was specific to one operator.

Site discussed this information with the operator, and quickly identified what the operator was doing to achieve the high retraction force. The operator was retrained, and now conducts the same operation with less than half the fatigue damage and unchanged production rates.
